Strengthening of the Riddes Viaduct Through UHPFRC-Based Rehabilitation

Hammad El Jisr Dr, Civil Eng., Lionel Moreillon Dr, Civil Eng. & Philippe Menétrey Dr, Civil Eng.

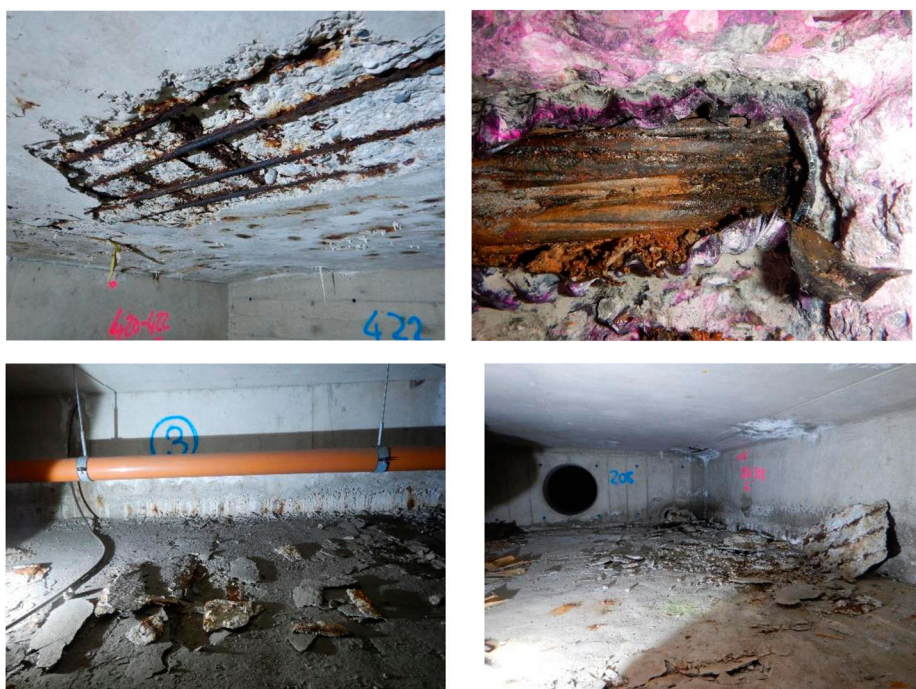
concrete, concrete spalling, the chloride content, and the mechanical properties of the steel reinforcement, the prestressing tendons and the encompassing grout. The inspection revealed significant damage in the concrete that rendered the deck prone to water ingress. Damage included cracking and spalling of the concrete cover. In fact, in some spans, cracks were even observed along the path of the prestressing tendons despite the high level of prestress in the box girders. Corrosion of the deck reinforcing bars was also noted. This was accompanied by extensive delamination of concrete in the vicinity of the heavily corroded reinforcement at both the top and bottom flanges (see Fig. 3). Furthermore, the integrity of

Fig. 3: Observed damage inside the box girder of the viaduct. Top right: corrosion of the top flange reinforcement and extensive spalling of concrete. Top left: corroded strands inside a prestressing duct that was opened during inspection. Bottom: spalling of concrete and AAR inside the box girder

the prestressing tendons was assessed at several locations in order to determine the level of corrosion as well as the physical and chemical quality of the injection grout. To that end, the level of alkali–aggregate reactivity was diagnosed both visually and through microscopic and mechanical analyses of the concrete properties. It was shown that corrosion had occurred in four out of six prestressing tendons at certain locations in the web of the box girder as illustrated in Fig. 3, and several tendons were either severed (i.e. actively cut) or slack. The destructive tests revealed that moderate to severe corrosion occurred in 22 out of the 182 drilled holes. Moreover, chloride-contaminated water ingress was detected along the length of some tendons: 65 of the 182 drilled holes showed chloride content in the grout, of which 18 exceeded 0.4% of the weight of cement.

The AAR had developed throughout the whole structure and foundations to a designated pathological level as per Ref. [3]. The tested concrete cores revealed that the elasticity modulus of the concrete had decreased by around 25%. Regarding water infiltration, it was revealed that the water-tightness of the bearing slab was inadequate and that the water drainage system inside the box girders had many defects. These findings were confirmed by the high chloride levels (up to 1.3% of the weight of cement) that were measured in the concrete.

In view of the conducted investigation, a retrofit intervention was deemed necessary in order to restore vital traffic on the bridge and delay the development of the AAR degrading mechanisms. The intervention aimed at optimizing the financial investment for the reduced remaining lifespan of the viaduct. Accordingly, considering the size of the viaduct and to limit the extent of the interventions, traffic on the main viaduct had to be modified by reducing the number of lanes in each direction from two to one. This implied that the right segments over the SBB Simplon rail line, the plain and the river Rhône, which were in a worse condition, should be put out of service as illustrated in Fig. 4.

The main intervention on the preserved decks comprised the installation of a reinforced and waterproof layer of UHPFRC.

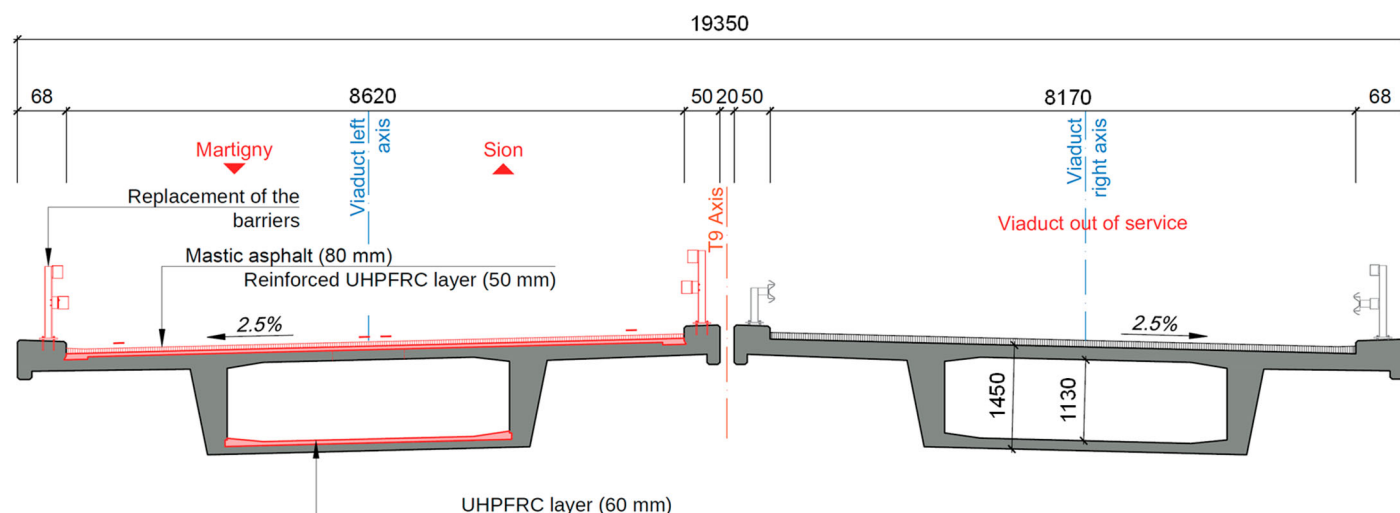
Fig. 4: Left: box girder to which the intervention was implemented. Right: box girder taken out of service

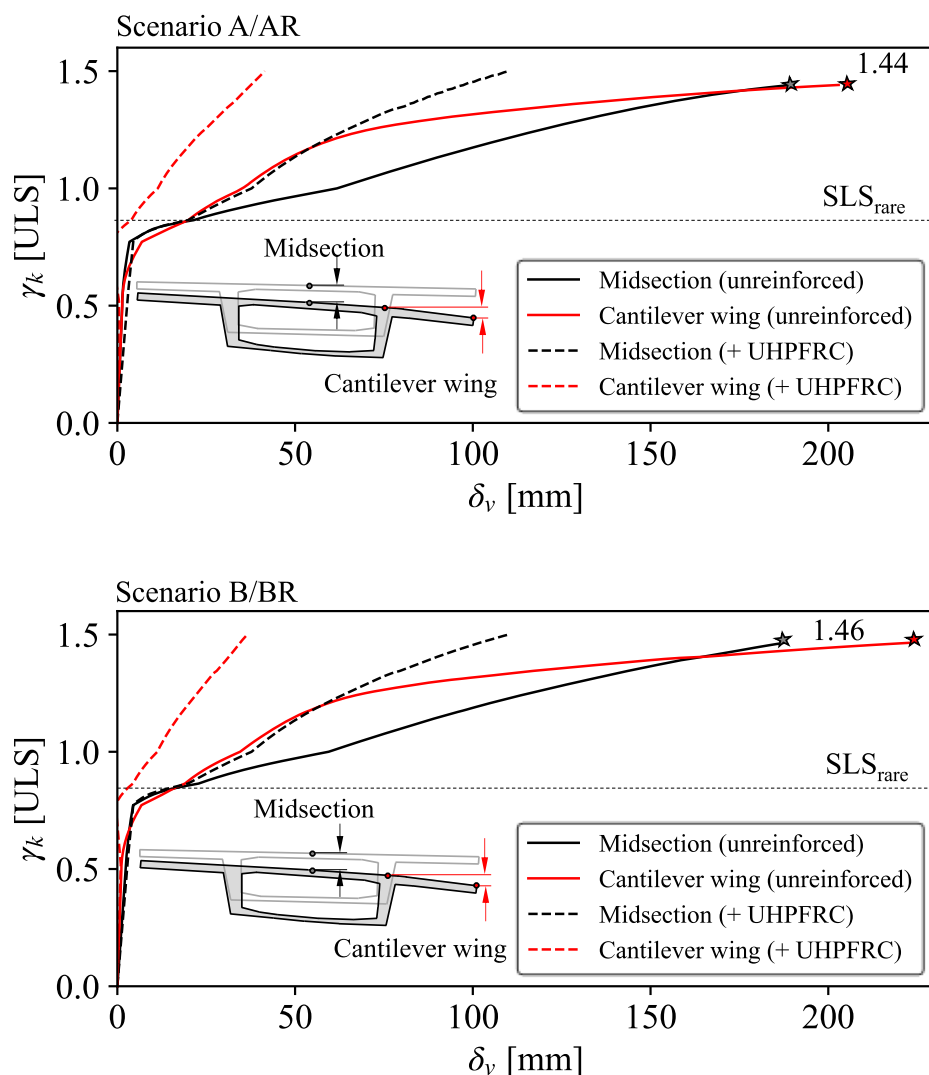
Referring to Fig. 6, the addition of a UHPFRC layer significantly influences the response, particularly at normalized loads γ_k exceeding 1.0. In the unreinforced scenarios A and B, the run was terminated at $\gamma_k = 1.44$ and 1.46, respectively, owing to excessive plastification in the bottom flange and at the tip of the cantilever wing. Capping of the ultimate load, indicative of the failure load, was observed. On the other hand, both reinforced scenarios attained $\gamma_k = 1.5$. Hence, the load-carrying capacity of the reinforced span is at least 1.5ULS.

Fig. 6: Normalized load–displacement curves for the different scenarios. Top: symmetric degradation of the prestressing tendons. Bottom: asymmetric degradation of the prestressing tendons

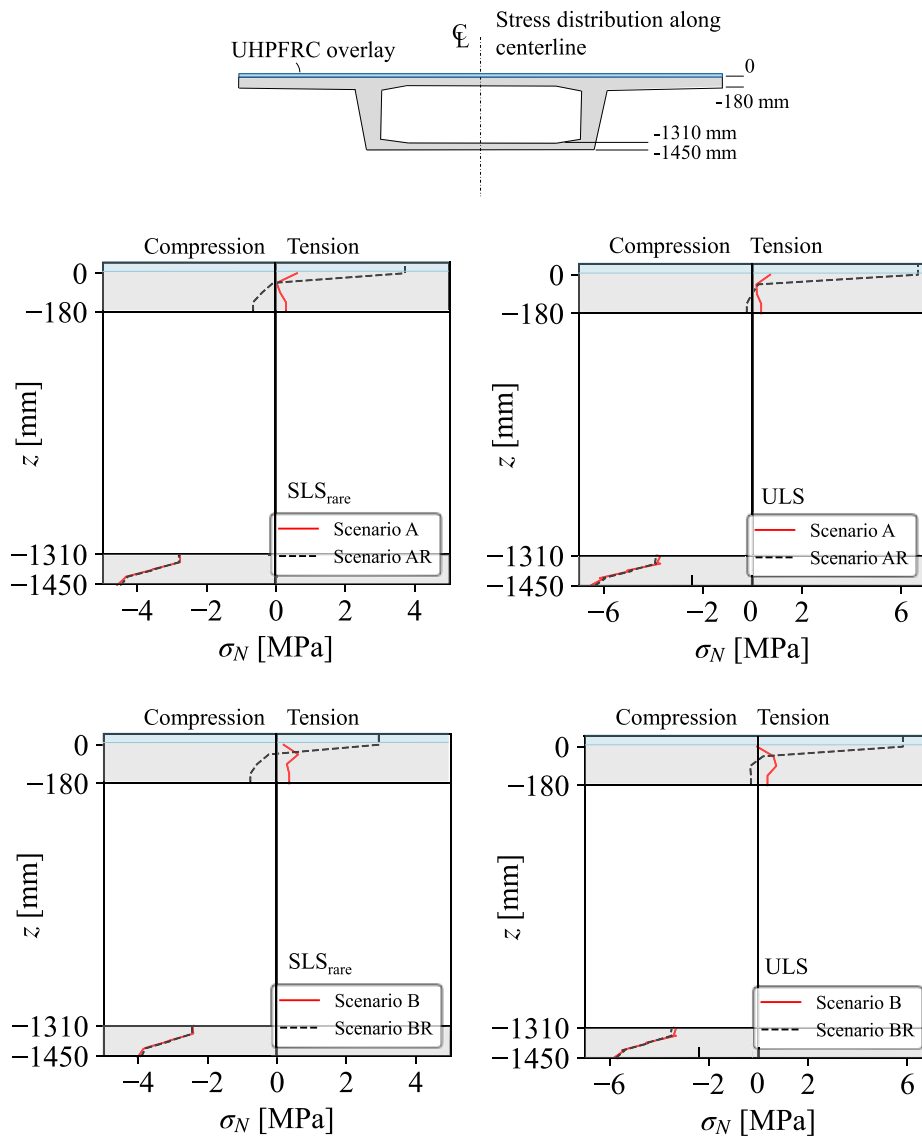
The mean element stresses along the depth were plotted along the depth of the box girder as shown in Fig. 7. Note that these plots are only indicative since they do not show the stress across the width of the cross section and the stress redistribution that occurs following plastification. Nevertheless, it was observed that, for the unreinforced scenarios (A and B), the stresses in the top flange were low and capped at around 1.0 MPa. The stress distribution was

Fig. 7: Stress distribution along the centreline of the box girder section at the North pier. Top left: SLS_{rare} , scenarios A/AR. Top right: ULS, scenarios A/AR. Bottom left: SLS_{rare} , scenarios B/BR; bottom right: ULS, scenarios B/BR

similar at SLS_{rare} and ULS, which indicates capping of the hogging moment. For the reinforced scenarios, the peak tensile stresses were 4 and 3 MPa at SLS_{rare} and 7 and 6 MPa at ULS for scenarios AR and BR, respectively. The cross section was able to resist a higher hogging moment at ULS without any plastification in the UHPFRC layer. Moreover, the addition of the UHPFRC layer shifted the neutral axis upwards, which resulted in a decrease in the tensile stresses and hence tensile cracking in the web. In fact, the web of the box girder was subjected to compressive stresses as shown in Fig. 7.

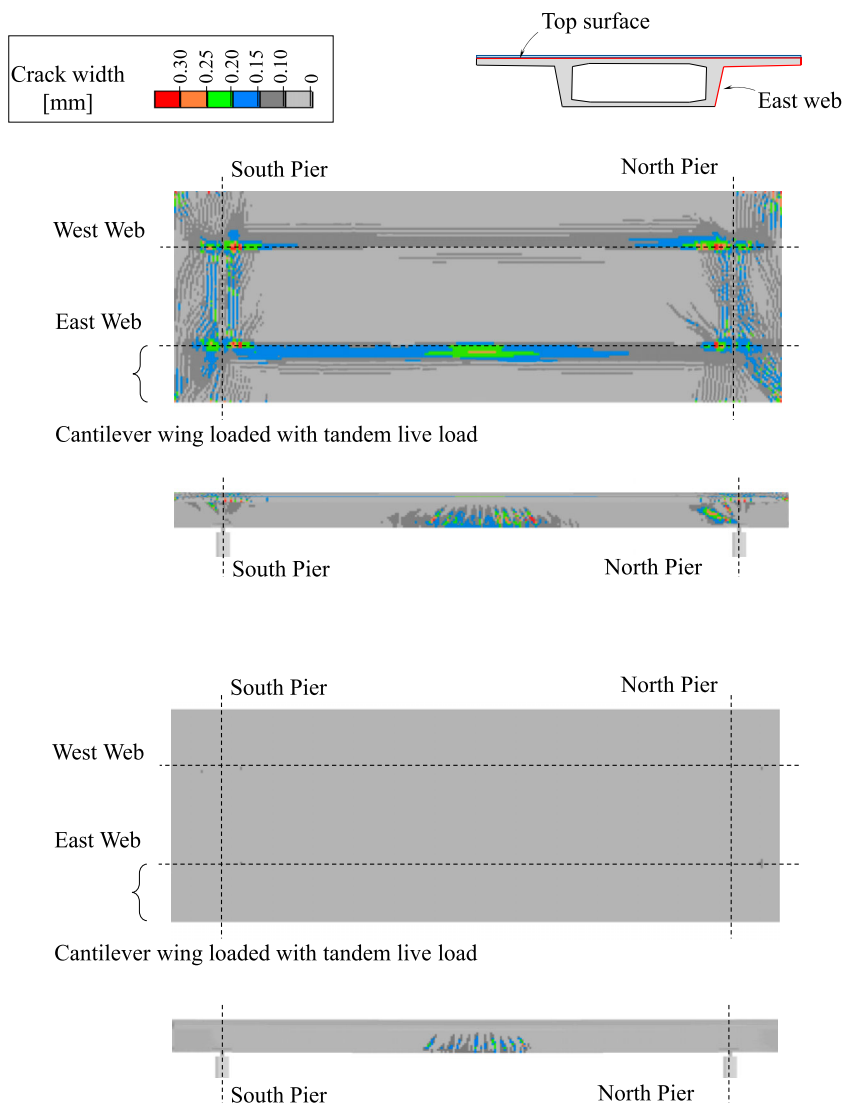
For brevity, only scenarios A/AR are shown herein. Figure 8 illustrates that, in the unreinforced scenario (A), severe cracking occurred at the edge of the loaded cantilever wing, around the piers and at midspan. The crack widths exceeded 0.3 mm. The crack pattern revealed crack propagation in the top flange around the piers and

towards the web of the box girder. On the other hand, in the reinforced scenario (AR), crack propagation was limited to the bottom region of the box girder at midspan and crack widths were within 0.15 mm. The integrity of the top flange of the box girder (beneath the UHPFRC layer) and the regions in the vicinity of the piers was maintained. This explains the lower deflections observed in the reinforced scenario at ULS compared to the unreinforced scenario, as mentioned earlier. Moreover, in scenario AR with a UHPFRC layer, no tensile cracking occurred in the top flange at the support of the loaded cantilever wing as opposed to the unreinforced scenario. Accordingly, the failure of the cantilever wing that was observed in the unreinforced scenario did not occur.

Fig. 8: Crack pattern at ULS: comparison between the (top) original section, scenario A and (bottom) section with UHPFRC overlay, scenario AR

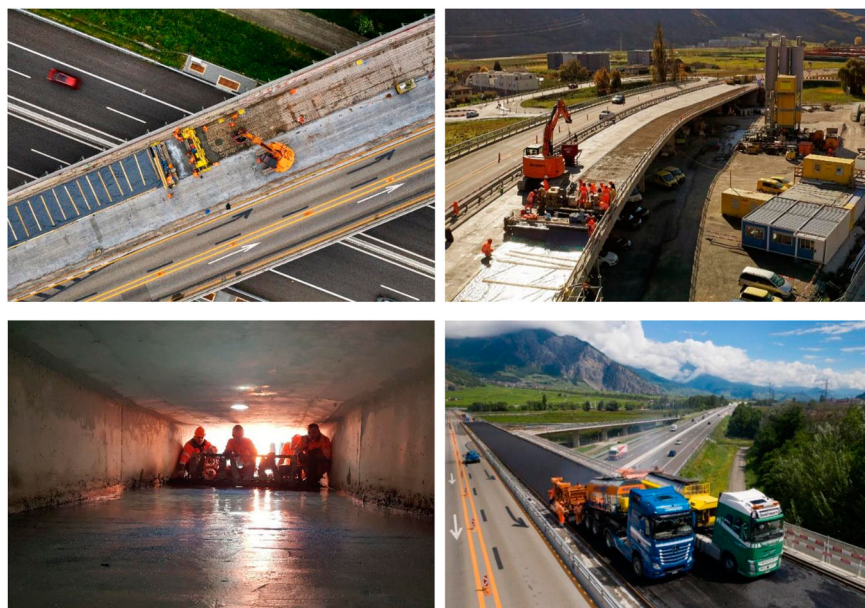
Fig. 9: Retrofit intervention in the Riddes viaduct. Top: installation of the UHPFRC layer on the deck (© Adrien Pilet, reproduced with permission). Bottom left: installation of the UHPFRC layer inside the box girder. Bottom right: application of MA on top of the UHPFRC layer on the deck slab

The viaduct was maintained in an unpropped state during the rehabilitation process. Installation of the reinforcing layer was conducted by first milling and removing the pavement and waterproofing. This was followed by hydrodemolition of the entire wearing surface to a thickness of 20 mm in order to remove the damaged concrete and create a rough surface for bonding the UHPFRC. Near the curbs, grooves were made to bond the UHPFRC layer to the existing reinforcement. The UHPFRC was laid by hand and directed towards grooves made in the deck slab (see Fig. 9).

To complete the retrofit process of the viaduct, the pavement and pavement drainage system were reconstructed. Mastic Asphalt (MA) with an average thickness of 80 mm was applied directly on top of the UHPFRC layers on the viaduct and ramps after treating the surface with very-high-pressure water jets. Furthermore, the inside surface of the bottom flange of the box girders, which showed severe degradation, was retrofitted with a 60 mm thick layer of

reinforced UHPFRC. These repairs were deemed necessary to enhance the flexural resistance of the box girder sections under sagging and hogging bending, as well as the stiffness of the deck slab. The intervention also provides waterproofing of the concrete to limit the further development of AAR.¹⁰
