Rehabilitation of Flon Arch Bridge

Claude Broquet, Guillaume Fargier, Philippe Menétrey

INGPHI SA, Lausanne, Switzerland

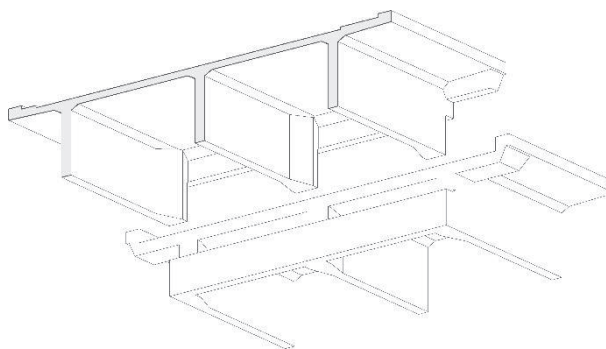
Figure 4. 3D model of a half-joint

The 32-cm width of the support zone at the half-joints is too small, according to the codes, to prevent the deck from falling under seismic load [3]. Moreover, the bar placement in the joint is not ideal as some of the most important bars are not correctly anchored, according to the codes [4].

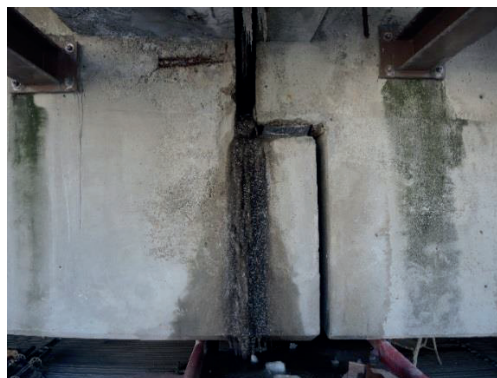
The observed degradations of the half-joints cause a risk to the structural integrity of the bridge. The concrete is spalling in various locations, showing corroded steel rebars with a significant loss of the cross-section. These damages are mainly due to important amounts of road water streaming from the road joints which have lost their waterproofing, as seen in Figure 5.

Figure 5. Important water streaming on a half-joint

Because of the risk linked to the half-joints and the difficulty to repair them in a durable way, it was decided to concrete all of them. With this solution, all risks linked to keeping and repairing them are removed (brittle failure, fall of deck in case of seismic activity & progressive degradation).

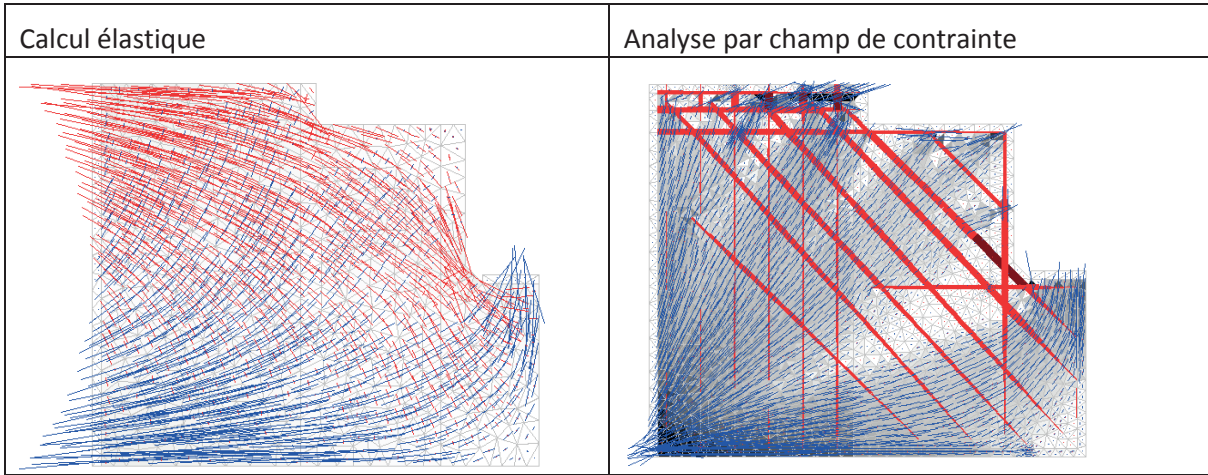
The half-joints were first verified using stress fields and the results are given in Figure 6. According to

this method, the failure load of the half-joint is 1'560 kN.

Figure 6. Stress fields model ($V_d = 1'560$ kN)

These two analysis methods gave a security factor close to 1, considering a perfect bond of the rebars and the full cross-section of the rebars. In further analysis, a 10% loss of the rebar cross-section due to corrosion is considered. Moreover, the real anchorage based on the indications of the as-built drawings is also considered. The security factor then reduces to 0.6 which is not acceptable.

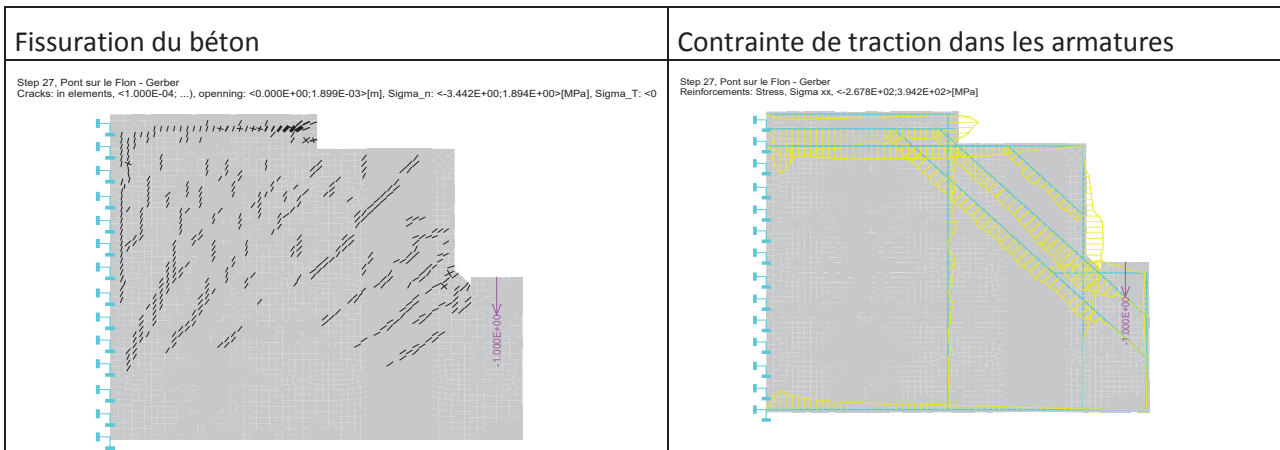
Figure 7. Non-linear finite element model ($V_d = 1'450$ kN) with Atena

[8] using the Menétrey – Willam [9] material model. The results of this analysis are shown in Figure 7. The failure load is 1'450 kN.

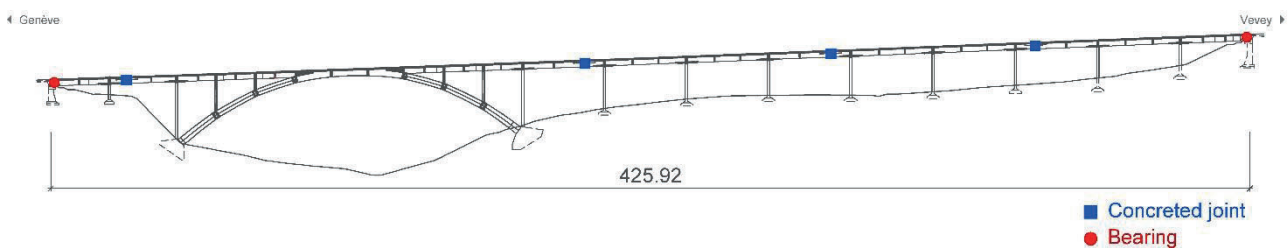
Figure 8. Modified bridge static system.

However, concreting all the half-joints to create a continuous structure can only be done if the bridge movements due to temperature change is allowed at the abutments. It is thus a change in the static system of the bridge as illustrated in Figure 8.

The concreting of the half-joints to create a continuous structure leads to an increase of the bending moment in the end piers of the bridge. A reduction of the bending stiffness of the piers and of the foundation soil stiffness was considered to verify the piers. Therefore, the action effects could be reduced, and it could be shown that almost all the piers satisfy the code requirements. Only the shortest pile located on the Geneva-side was strengthened for bending and shear.

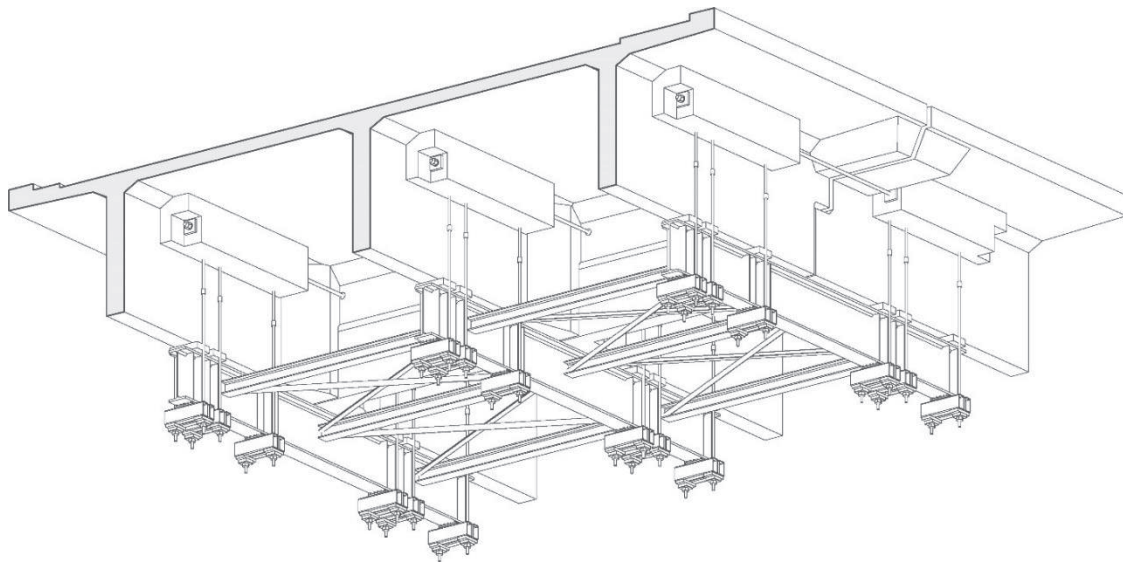
Figure 9. 3D view of the half-joint with the steel structure used for concreting.

During the concreting of the half-joints, the temporary steel structure under the longitudinal beams of the bridge deck allows the transmission of the action effects from one side of the half-joints to the other, as shown in Figure 9.

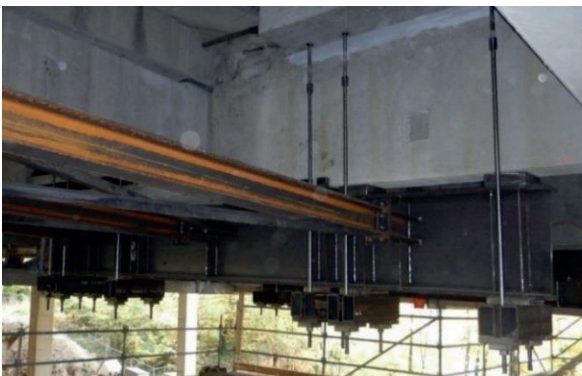
Figure 10. Steel structure supporting the half-joints

To limit the differential displacement between both sides of the half-joint, the steel structure is sandwiched to the longitudinal beams using flat-jacks. The service load effects are introduced into the steel structure and the bearings are partly unloaded. The steel structure is shown in Figure 10.

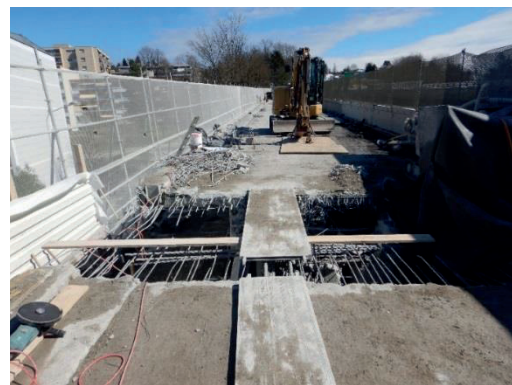
The half-joint is demolished, as shown in Figure 11. During this work, high chloride contamination was measured in the concrete of the half-joints.

Figure 11 . View of the half-joint zone on 1/3 of the highway surface.

The reconstructed longitudinal beams are concreted to create a rigid and continuous system in place of the half-joints. The link between both sides is done by insuring continuity of the longitudinal steel reinforcement and completed by prestressing bars anchored in concrete protrusions on each side of the beam.

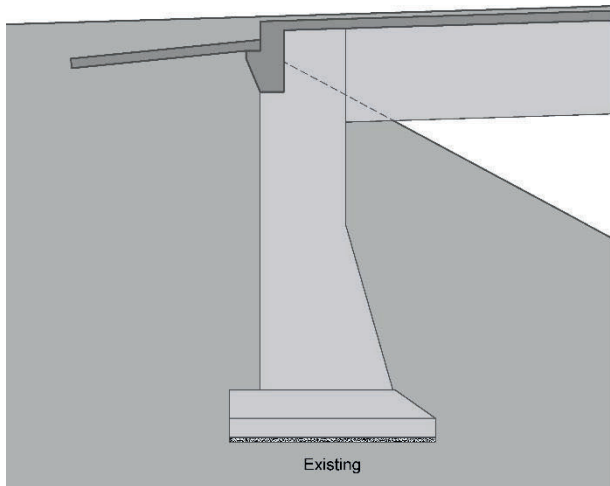
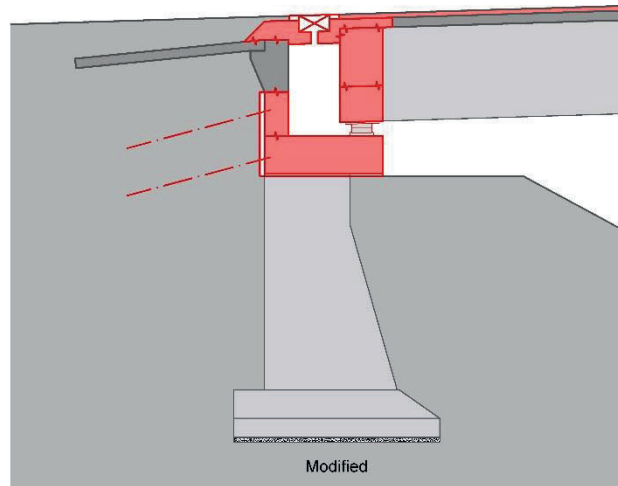
Figure 12. Releasing the abutments and creation of an access

The new abutments will include road joints and bridge bearings to allow the expansion of the bridge. To create these new structures, the beam-column connection in the existing abutment must be demolished at both ends of the bridge.

The abutments are equipped with road joints and sliding bearings easily accessible for any maintenance work.

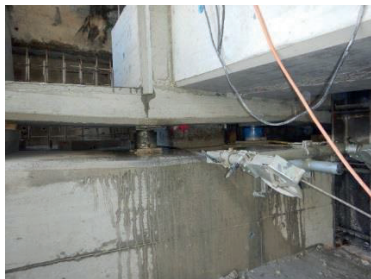
Figure 13. Bridge deck resting on the new concrete supporting bloc during the jacking

The new abutment was built underneath the bridge deck and the loads were transferred using jacks, as shown in Figure 13.

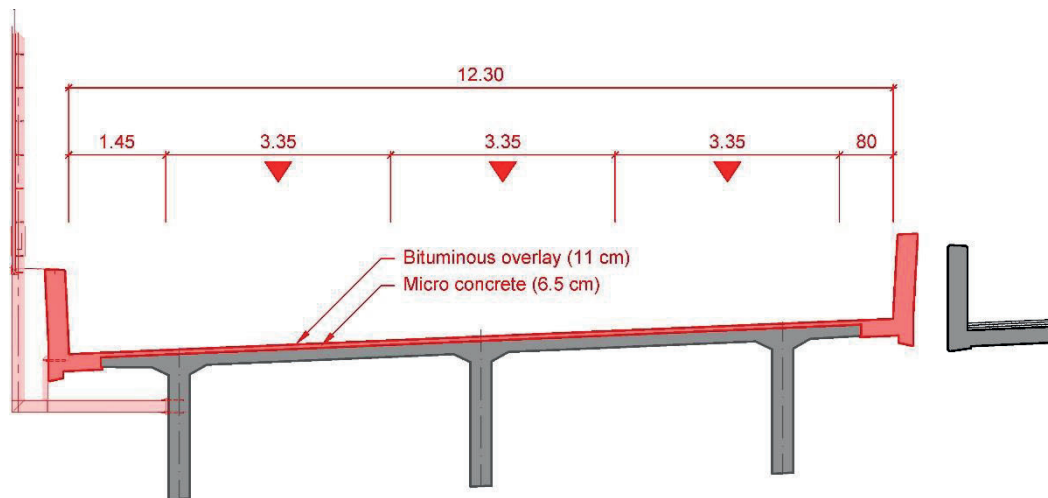
Figure 14. Coupe type du tablier renforcé

The bridge deck was rehabilitated and strengthened as shown in Figure 14. The curbs were replaced by parapets, the deck slab was strengthened with micro-concrete placed on the surface after removing the cover concrete by high pressure water jets. The waterproofing and the bituminous overlay were also redone.
