Strengthening of the Riddes Viaduct Through UHPFRC-Based Rehabilitation

Hammad El Jisr Dr, Civil Eng., Lionel Moreillon Dr, Civil Eng. & Philippe Menétrey Dr, Civil Eng.

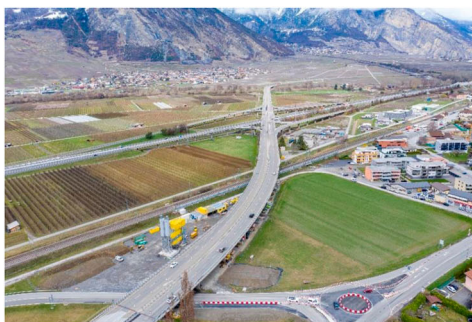
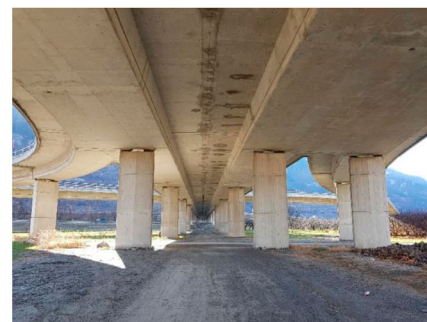
Fig. 1: The Riddes viaduct. Left: location in the Rhône valley. Right: view of the main viaduct near the junction

The Riddes viaduct, located on the T9 Martigny–Sion cantonal road, crosses the Rhône valley as shown in *Fig. 1*. The general layout and geometry of the viaduct is described by Ref. [13] Referring to *Fig. 2*, the viaduct spans four passages: the SBB Simplon rail line (in orange), the N09 motorway (in green), the plain (in violet) and the river Rhône (in magenta). Four ramps, forming a diamond-shaped junction, connect the viaduct to the N09 motorway platform (see *Figs. 1*

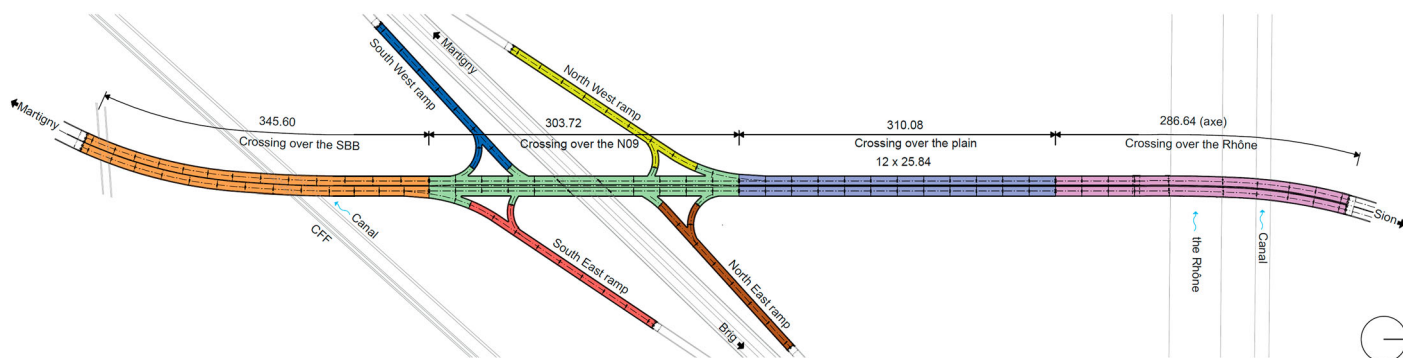
Fig. 2: General layout (plan view) of the viaduct

and 2). The total length of the viaduct, with its ramps and two 1250 m long parallel bridges, is around 3300 m, which makes it one of the longest bridges in the Canton of Valais. The viaduct consists of a multi-span box girder separated into eight sections by means of pavement joints. Typical span lengths range between 24 and 28 m. Over the N09 motorway and the river Rhône, the span lengths increase to 40 and 53 m, respectively.

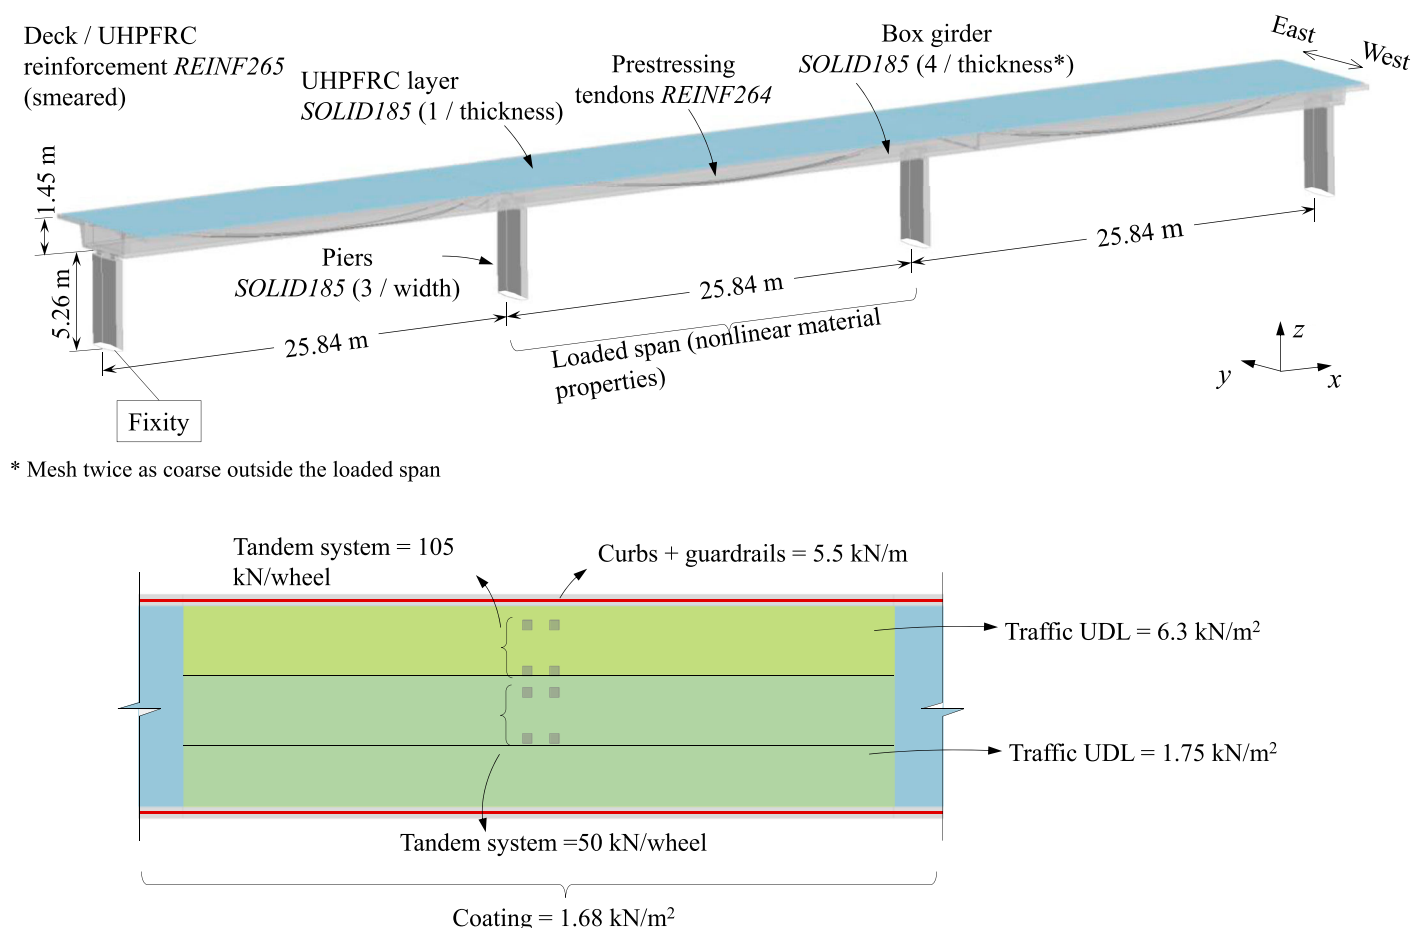
Fig. 5: Continuum finite element model schematic. Top: geometry, element types and boundary conditions. Bottom: applied load on the midspan

This CFE model specifics of a section of the Rides viaduct passing over the plain are described herein. This section of the viaduct comprises 12 straight spans, each with a length of 25.84 m. For the sake of computational efficiency, three spans were modelled, and traffic loads were applied on the middle span as illustrated in Fig. 5. The commercial finite element software ANSYS^{®17} was used for this purpose.

Referring to Fig. 5, the deck, piers and UHPFRC layer were meshed with first-order brick elements, SOLID185. Sweep meshing was employed to produce elements with reasonable aspect ratios. Moreover, the mesh was refined in the middle span where traffic loads were applied. For the box girder corresponding to the middle span, four elements per flange/web thickness were employed. On the other hand, the two edge spans were meshed with a coarser mesh. Reinforcing bars in the concrete deck and the UHPFRC layer were modelled using a smeared approach. To account for the effects of prestressing in the deck, the prestressing tendons were modelled

in which G is the self-weight of the viaduct, G_s is the superimposed dead load, P is the prestress, and $LM1$ is the live traffic load corresponding to load model 1 according to SIA 269.¹⁴ The values of the uniform distributed traffic load as well as the tandem system loads are shown in Fig. 5. Finally, in the fifth stage, the middle span was loaded until failure up to 1.5ULS.
